Contract #: 04-0120F4

WELDING INSPECTION REPORT

Resident Engineer: Siegenthaler, Peter **Report No:** WIR-023886 Address: 333 Burma Road **Date Inspected:** 20-May-2011

OSM Arrival Time: 700 **Project Name:** SAS Superstructure **OSM Departure Time:** 1900 **Prime Contractor:** American Bridge/Fluor Enterprises, a JV

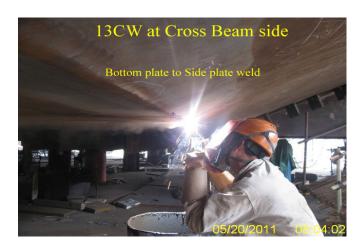
ZPMC welding personnel performing Shielded Metal Arc Welding of Complete Joint Penetration welds joining the bottom plate to side plate weld joint located on 13CW at cross beam side. The weld is designated as SEG3015A-012. The welder is identified as 057220. ZPMC QC Mr. SHI LIE was onsite monitoring the welding variables. The inprocess Shielded Metal Arc Welding appears to be progressing in compliance with WPS-B-P-2214-B-U2-FCM-1. Further weld detail mention in attached picture.
